Manhole Inspection Summary

Manhole # S37G__010MH

Insp Date: **8/19/08 9:46 AM**

Location Address: **cross from 55 market pl** Cross Street: **e lombard st**

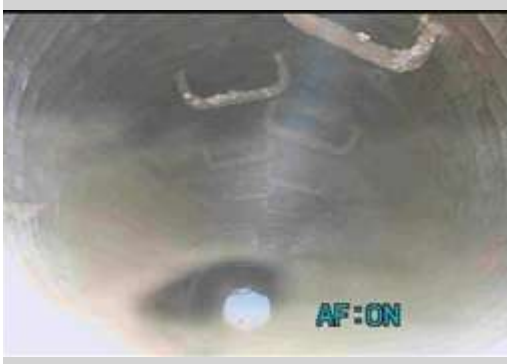
Defect 2

Steps Count: **10** Missing: **0** ☒ **Corroded**

steps

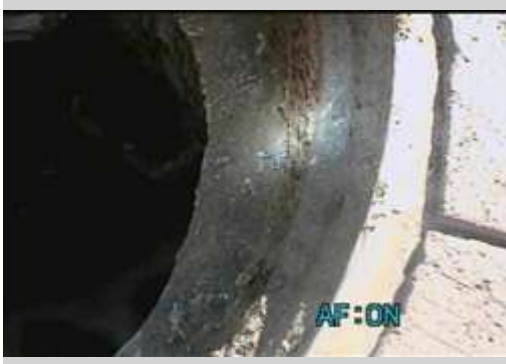
Defect 1

Frame Offset: **3** (in.) Condition: ☒ Sound ☐ Cracked ☐ Leaks

frame offset

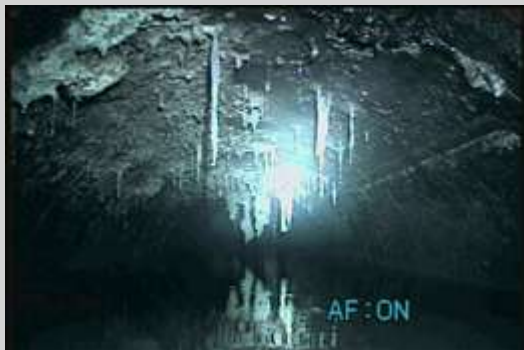
12 O'Clock Outflow

27 in. Circular Gravity Sewer
Pipe Out @ 12 O'Clock

Invert Depth: 14.66 (ft.) Flow Characteristics: **Fast**

Deposits: ☒ None ☐ Mud ☐ Sludge ☐ Debris ☐ Grease

Infiltration: **None** Pipe Seal Cond: **Unknown**

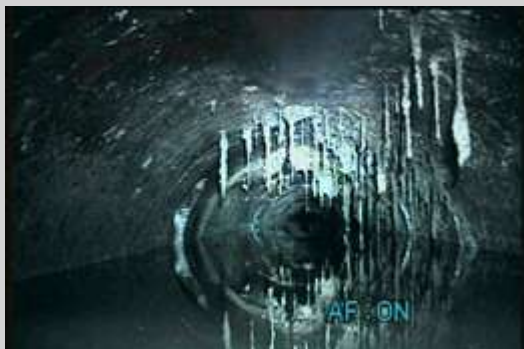
7 O'Clock Inflow

27 in. Circular Gravity Sewer
Pipe In @ 7 O'Clock

Invert Depth: 14.41 (ft.) Flow Characteristics: **Fast**

Deposits: ☒ None ☐ Mud ☐ Sludge ☐ Debris ☐ Grease

Infiltration: **None** Pipe Seal Cond: **Unknown**
